**Development of Advanced Surface Enhancement Technology
for Decreasing Wear and Corrosion of Equipment
Used for Mineral Processing**

ANNUAL TECHNICAL PROGRESS REPORT

(July 21st, 2005 – July 21st, 2006)

DE-FC26-03NT41787

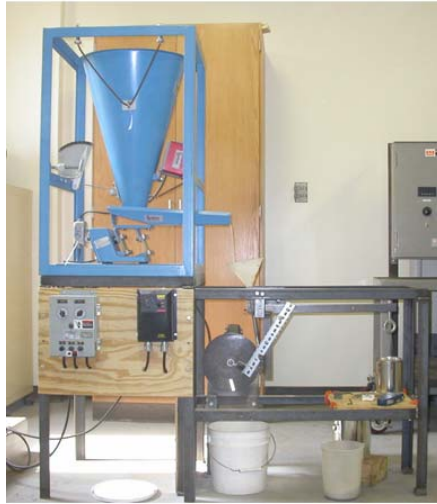
Figure 18. Abrasive wear tester

The new laboratory abrasive wear test rig, as shown in Figure 18, includes three parts which are sand feeder, control panel and test unit. The sand feeder is magnetic vibratory feeder which can provide steady sand flow. The feeder speed controller, power switch and DC motor speed controller were bolted on the control panel. Test unit includes a funnel, a specially designed sand nozzle, a DC motor, a steel wheel, a lever arm, a specimen holder, weights, etc.

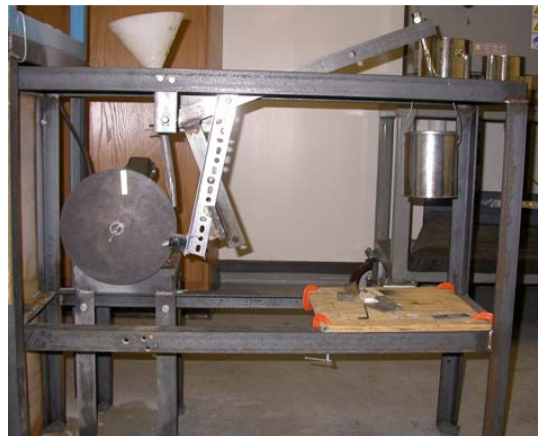
Figure 20. Test unit

During a test steady sand flow is introduced between the test specimen and the rotating wheel of the test unit, as shown in Figure 20. A test specimen (e.g., a coated sample) is pressed against the wheel at a specified force by means of the lever arm, which creates abrasive wear on the specimen surface. The wheel used in this setup was made of C1018 steel and was heat treated to get a hard surface (HRC>60). The wheel was set on the shaft of the DC motor and rotates clockwise thus its contact face moves in the direction of the sand flow. A mechanical counter was installed on the arm to count the revolutions of the wheel during a test. The pivot axis of the lever arm lies within a plane which is tangent to the wheel surface and normal to the horizontal diameter along which the load is applied.
